High temperature creep properties and microstructural examinations of P92 welds

HIGH TEMPERATURE CREEP PROPERTIES AND MICROSTRUCTURAL EXAMINATIONS OF P92 WELDS

Abstract

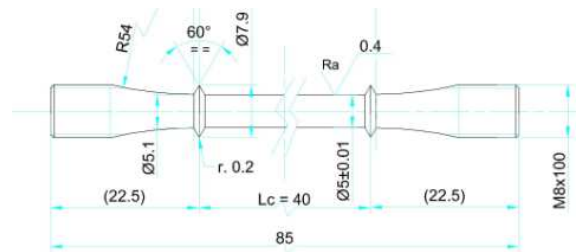
Smooth cross-weld specimens were extracted from the weldment, along the longitudinal axis of the pipe. Their geometry is presented in figure 1.

Figure 1: Scheme of creep specimen geometry.

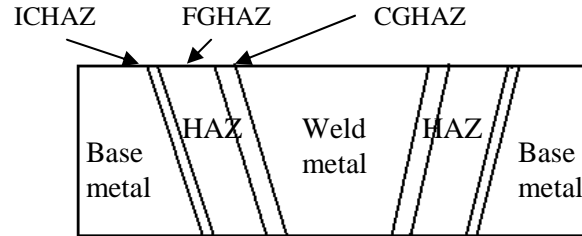
The various zones in the welded joint are schematically represented in Figure 2.

Figure 2: Scheme of the welded joint.

The area close to the weld metal shows coarse parent austenite grains and is called the coarse-grained zone (CGHAZ). Then, next to the CGHAZ, the HAZ presents an area with very fine parent austenite grains (FGHAZ). A last zone, located between the base metal and the FGHAZ, presents a particular microstructure, made of martensite laths and prior austenite grains denoted the intercritical zone (ICHAZ).

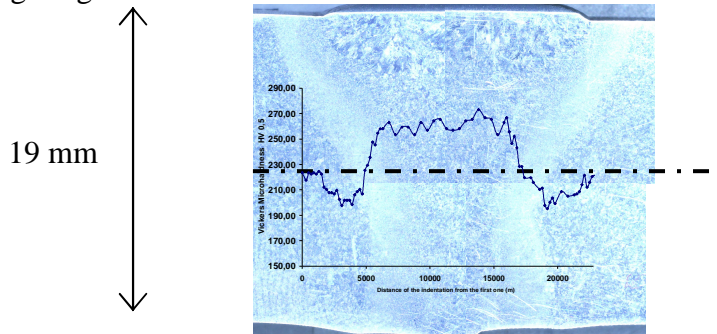
A microhardness profile performed at mid-thickness is symbolized by the dash-dot line in Figure 3. The combination of microhardness profiles and observations of the welded joint allows highlighting the location and the width of the different areas of the HAZ (Figure 4).

Figure3: Cross-weld microhardness profile combined with observations of the welded joint.

The weld metal is the harder part of the joint (the average value is 265 HV). The hardness in the HAZ is varying. A softened zone (200 HV) is observed in the HAZ next to the base metal. It probably corresponds to the ICHAZ. Then, the hardness strongly increases in the HAZ towards the weld metal. The area which is harder than the other zones and located close to the weld metal corresponds to the CGHAZ.

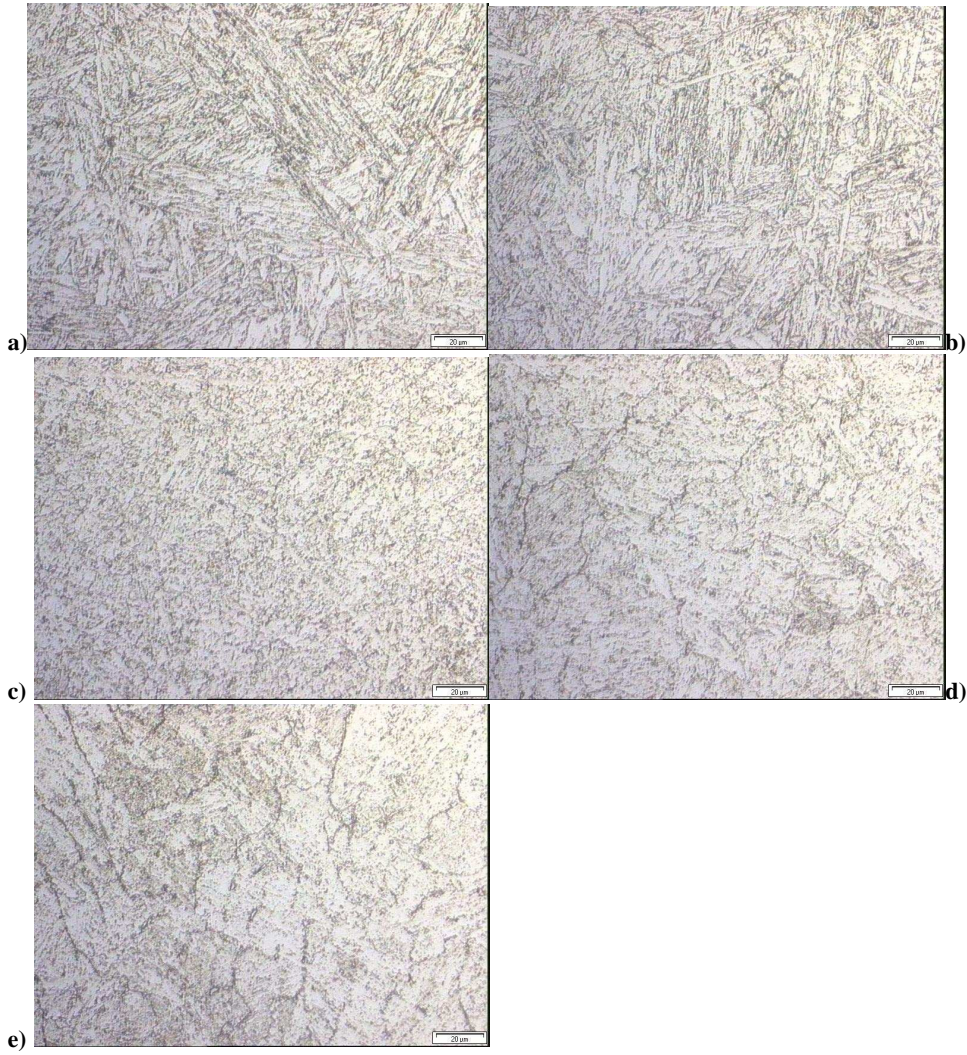
Figure 4: Optical observations of the different areas of the welded joint: a) the base metal, b) the intercritical area, c) the FGHAZ, d) the CGHAZ and e) the weld metal.

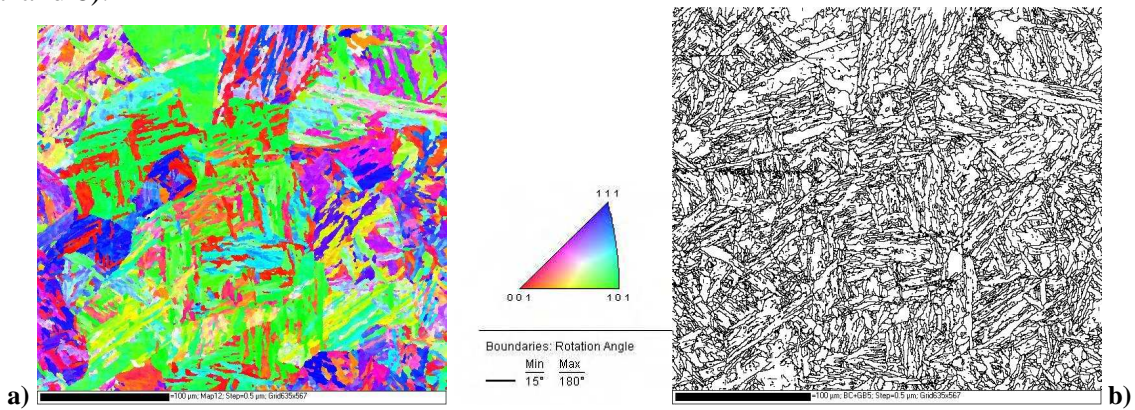
Figure 5: EBSD orientation map a) and boundary map (misorientation $>5^\circ$) b) of the base metal.

The microstructure of the base metal is a usual martensitic microstructure made of laths, arranged in blocks and packets (Figures 5 and 6) [4, 5].

The average size of a block is about 4 μm (Detection criterion: misorientation $> 5^\circ$). Giroux [6] estimated the subgrain size of the same base metal to be 0.37 μm . He estimated the average dislocation density of the material at about 2.10^{14} m^{-2} .

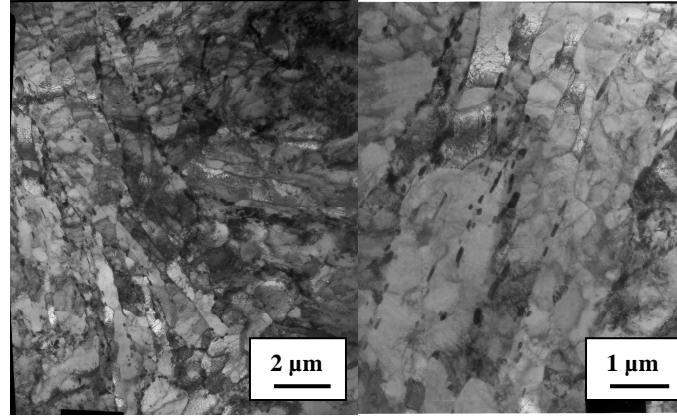
Figure 6: Bright Field TEM observations of the Base metal.

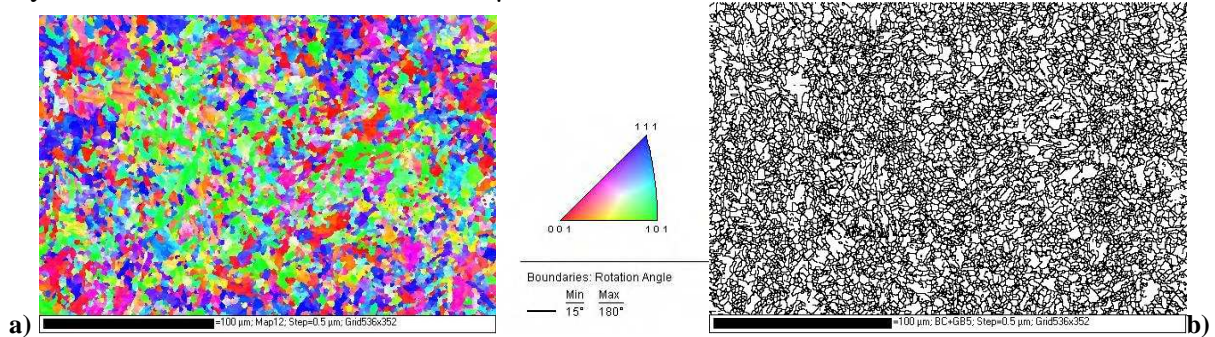
The fine-grained zone (FGHAZ) (figure 7) presents a microstructure with very fine crystals, which mean size is about 2.9 μm .

Figure 7: EBSD orientations map a) and boundary map (misorientation $>5^\circ$) b) of the fine-grained zone.

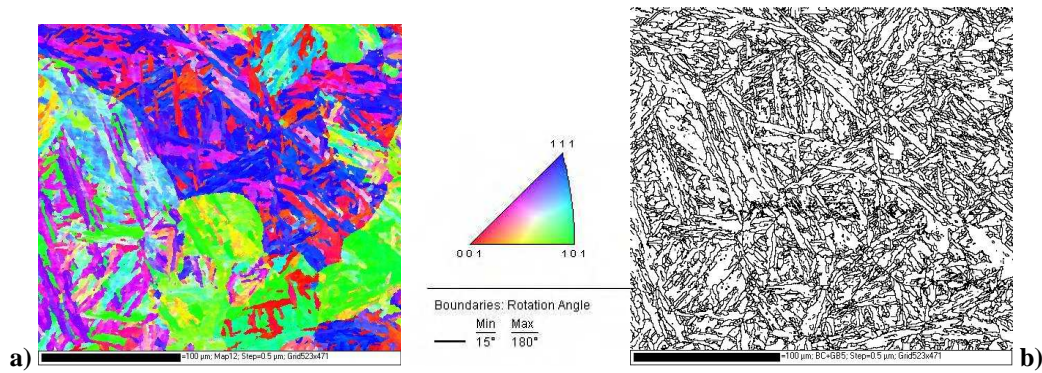
Figure 8: EBSD orientations map a) and boundary map (misorientation $>5^\circ$) b) of the softened zone.

EBSD observations of the softened zone show that the microstructure is very similar to that of the base metal at the investigated scale (figure 8). This suggests that the lower hardness might be due to a difference of subgrain or lath size or to a different precipitation state.

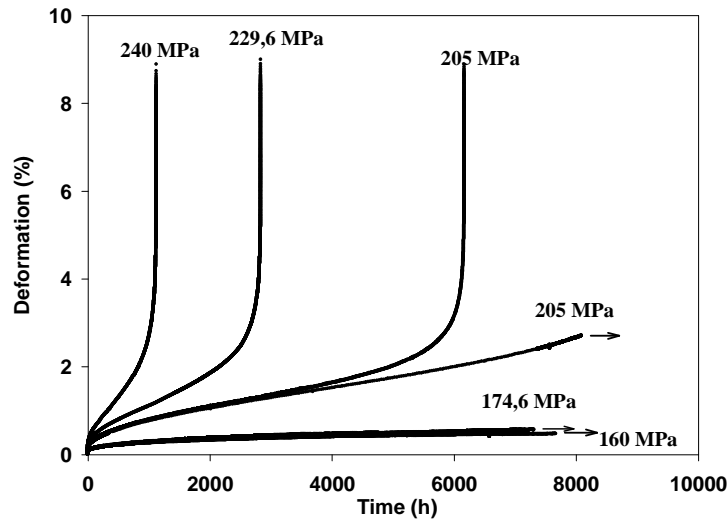
Creep tests results are summarized in Table 2 and Figure 9. Specimens subjected to applied stresses of 229.6 MPa and 240 MPa both broke in the HAZ, very close to the base metal, namely, in the ICHAZ. The specimen crept at 205 MPa has not been observed yet.

Figure 9: Creep curves at 550°C.

The fracture elongation is rather high (several percents). The three typical creep stages are clearly visible in Figure 9. The values of strain at the end of the first two stages are indicated in Table 3. The two creep curves at 205 MPa are superimposed for the first two creep stages but differ in the third stage. However, the ratio between both lifetimes will probably not exceed 2 or 3 as the third stage already started for the ongoing test.

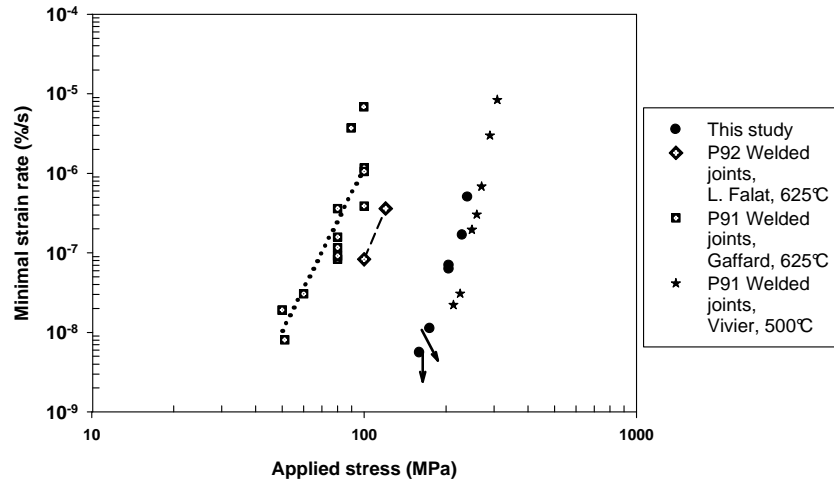
Figure 10: Minimal strain rate versus applied stress for welded joints [3, 6 and 7].

The minimum creep rates of the crept samples can be modelled by a typical Norton power-law curve defined by equation 1:

Where $\dot{\varepsilon}$ is the minimum creep rate, σ the applied stress, A and n are parameters depending on material and temperature. For this study, the model gives $n=11.57$. This relatively high value suggests that the creep deformation mechanism is controlled by dislocations motion, possibly together with an effect of internal stresses. This result can be compared with the values found at 500°C by Vivier [1] and at 625°C by Gaffard [7] for welded joints of P91 (Figure 10).

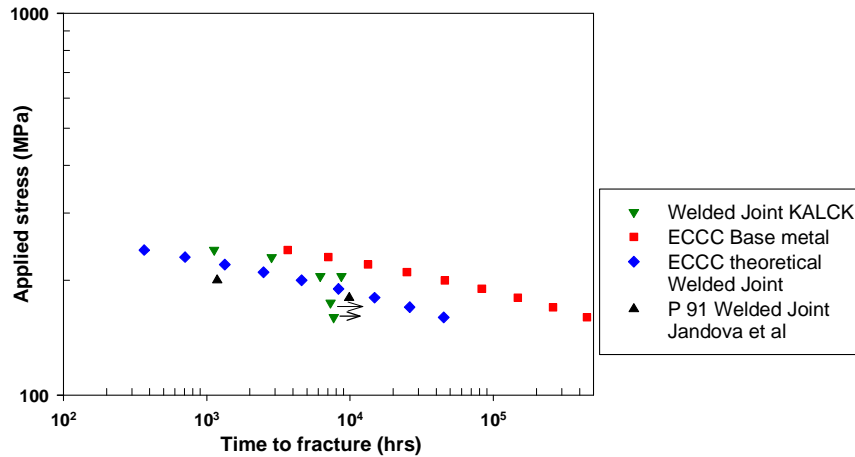
Figure 11: Applied stress versus time to fracture, at 550°C [1, 8].

In Figure 11, ECCC “theoretical” values correspond to times to fracture of welded joint calculated from ECCC base metal values and reduced by a factor of 10 compared to time to fracture of base material [8].

As expected, the creep strength of the welded joint is lower than the creep resistance of the base metal. The ratio between the values of the base metal and the actual welded joint is about 3.3 i.e. three times lower than that expected from “theoretical” ECCC values.

Besides, we can see that the diminution of P92 properties due to the welding is less significant than for P91. The difference between the Monkman-Grant properties (figure 12) of the welds compared to the base metal is much more pronounced for P91 than P92. This is consistent with the 3.3 ratio observed on the lifetime in figure 11.

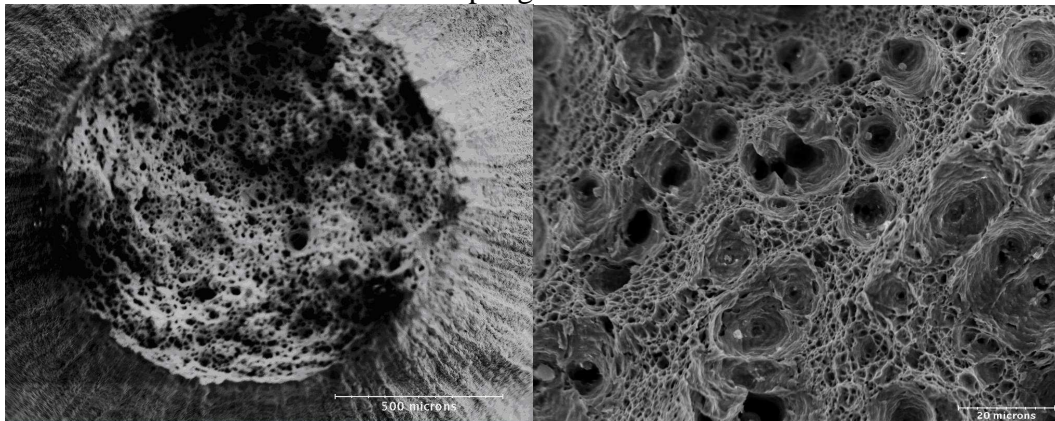
Fracture surfaces of broken samples present a circular shape. The fracture mode is transgranular ductile. The fracture surfaces in figure 13 exhibit many dimples, which is typical of a ductile fracture in the dislocation creep regime.

Figure 13: Fracture surface of the crept sample after 2837h (229.6 MPa, 550°C).

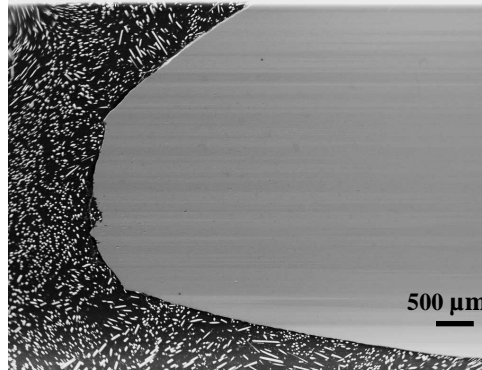
The samples (figure 14) display a pronounced reduction of area at the fracture surface, which highlights significant plastic deformation before fracture.

Figure 14: Necking area of a crept sample (240 MPa, 550°C).

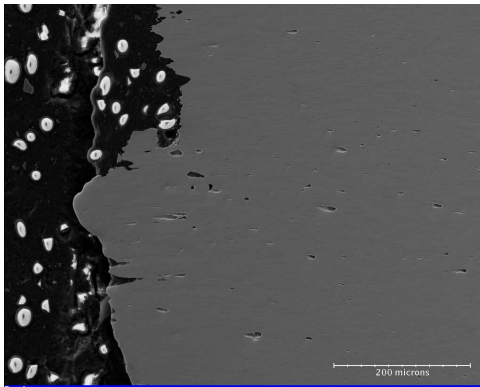
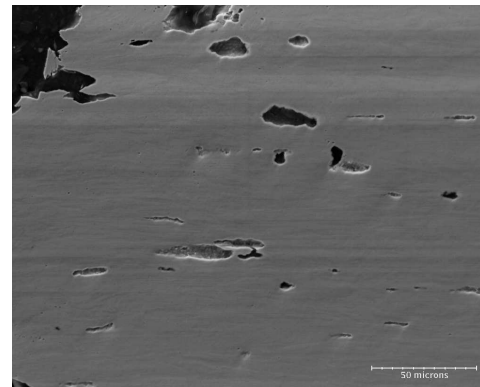
A lot of cavities and short cracks can be observed in the necking area of the broken specimen (Figure 15). Cavities are elongated along the loading direction.

Figure15: SEM observations of damage in the necking area of crept sample (240 MPa, 550°C, cross-section).

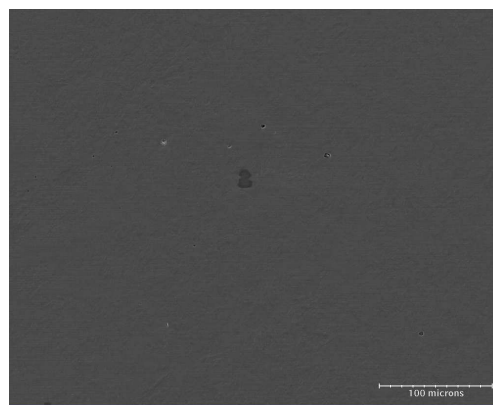
Figure 16: SEM observations of the cross-section of the crept specimen far from the necking area (240 MPa, 550°C).

Far from the necking area (figure 16), much lower cavities are concentrated in the necking zone. Therefore, the damage mechanism does not seem to be controlled by vacancy diffusion at 550°C in the tested conditions. This assumption is in agreement with the significant reduction of area and the Norton parameters.

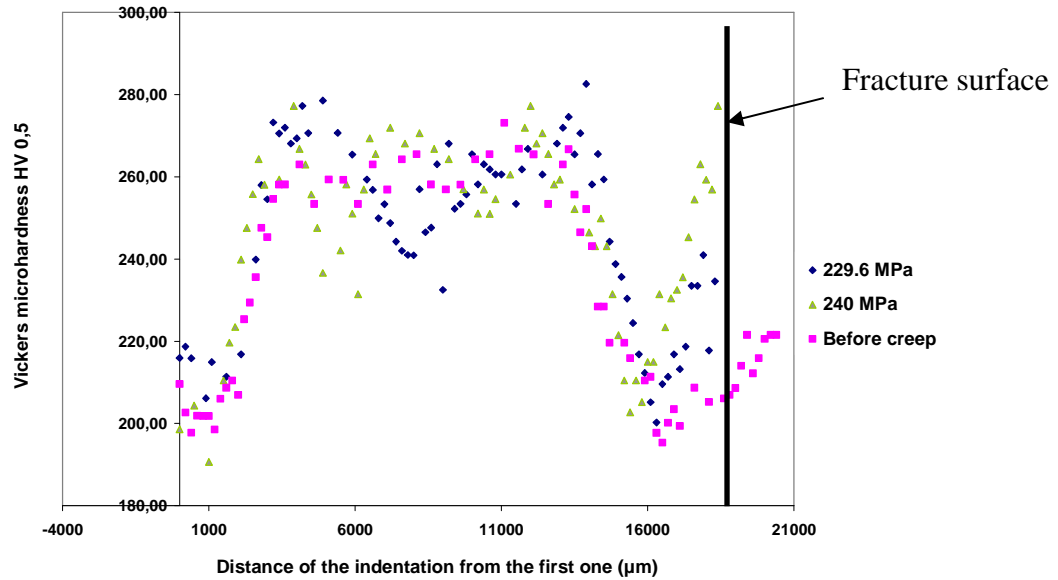
Microhardness profiles were measured on longitudinal cross sections of two creep fractured samples (figure 17), showing a significant increase in hardness in the necking area. This fact is linked to the strain hardening occurring during deformation. Moreover, in the weld metal, hardness values are more scattered than before creep.

Figure 17: Cross-weld microhardness profiles of two crept specimens

The microhardness profiles allowed determining the location of fracture in two specimens. Fracture occurred in the intercritical area for both samples. Table 5 presents the fracture location of samples having experienced creep tests under different conditions.
